1st Sunningdale Scout HQ  
Sandy Lane  
Sunningdale  
SL5 0ND

Management Survey

Site ID: WO16984  
Report Ref: WO16984

Client: 1st Sunningdale Scout Group

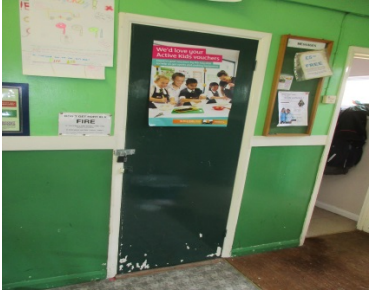
Building	Floor	Room/Area	Area ID	Reason for Non Access	Photos
SCOUT HQ	Ground	BROWNIES CUPBOARD	Can7167	No access, cupboard locked and code unknown.

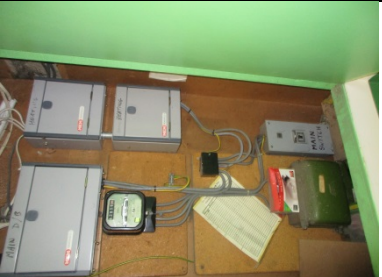
SCOUT HQ	Ground	ELECTRICS WITHIN CUPBOARD	Can7168	No access, live services.

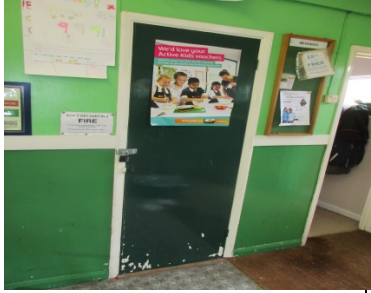
Building	Floor	Room/Area	Area ID	Reason for Non Access	Photos
SCOUT HQ	Ground	BROWNIES CUPBOARD	Can7167	No access, cupboard locked and code unknown.

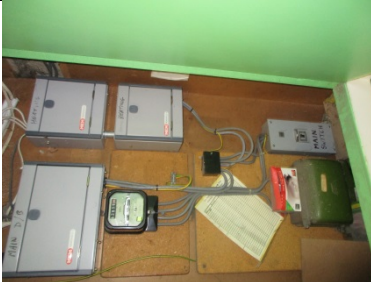
SCOUT HQ	Ground	ELECTRICS WITHIN CUPBOARD	Can7168	No access, live services.

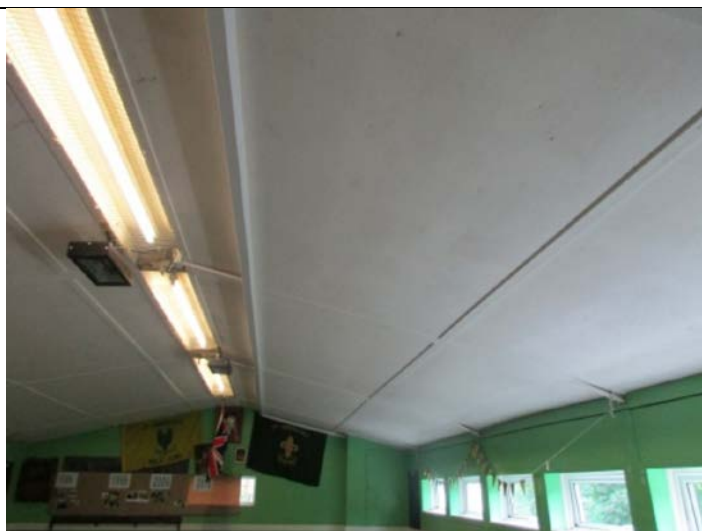
**Photograph No: 01**

<b>Licensable:</b>	N/A
<b>Comments:</b>	WOODEN PANELLING THROUGH CENTRE OF LIGHTS AND EDGES
<b>Recommendations:</b>

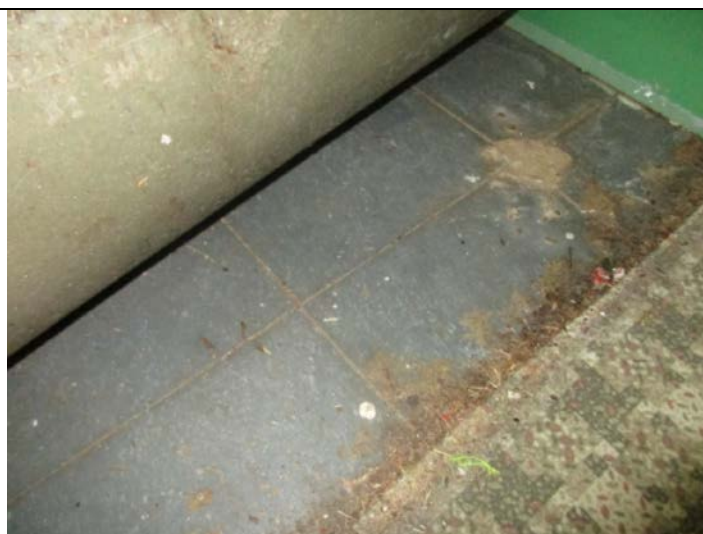
**Photograph No: 03**

<b>Licensable:</b>	N/A
<b>Comments:</b>	BLUE VINYL TILES BELOW CARPET
<b>Recommendations:</b>

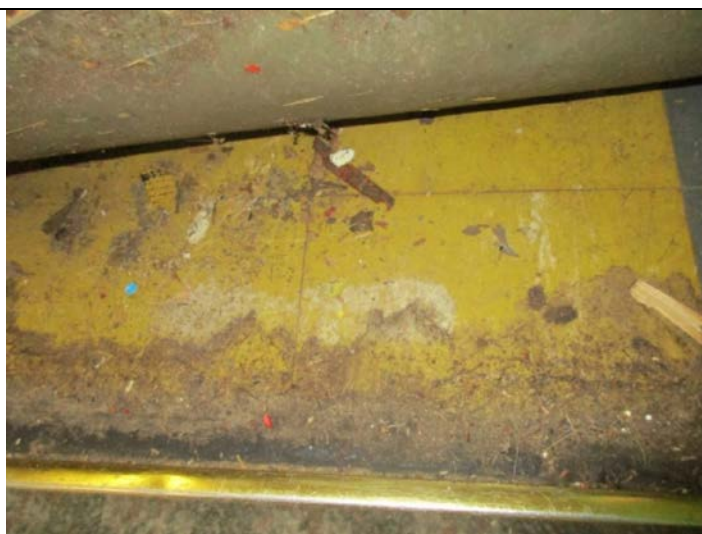
**Photograph No: 03**

SCOUT HQ	GROUND	MAIN HALL	YELLOW VINYL TILE BELOW CARPET	WO16984/008	CHRYSTILE (WHITE)	75 SQ M	FLOOR TILES	LOW DAMAGE: A FEW SCRATCHES OR SURFACE MARKS	COMPOSITE MATERIALS	MANAGE AND LABEL	3

<b>Product Type:</b>	FLOOR TILES	1	<b>Condition:</b>	LOW DAMAGE: A FEW SCRATCHES OR SURFACE MARKS	1
<b>Surface Treatment:</b>	COMPOSITE MATERIALS	0	<b>Location:</b>	ROOM <100 SQ MTR	0
<b>Asbestos Type:</b>	CHRYSTILE (WHITE)	1	<b>Amount:</b>	75 SQ M	
<b>Assessment Category</b>	VERY LOW		<b>MRA Score</b>		3

<b>Licensable:</b>	NO
<b>Comments:</b>	YELLOW VINYL TILE BELOW CARPET
<b>Recommendations:</b>	MANAGE AND LABEL

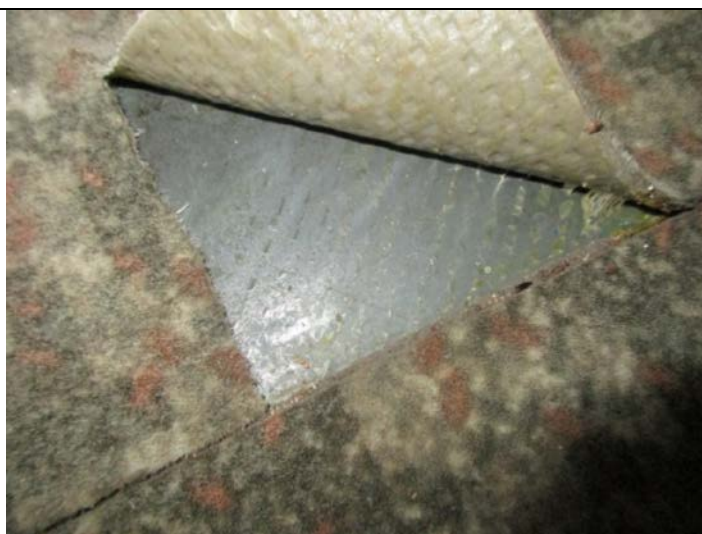
**Photograph No: 05**

<b>Licensable:</b>	N/A
<b>Comments:</b>	VISUALLY SIMILAR TO WO16984/07/02
<b>Recommendations:</b>

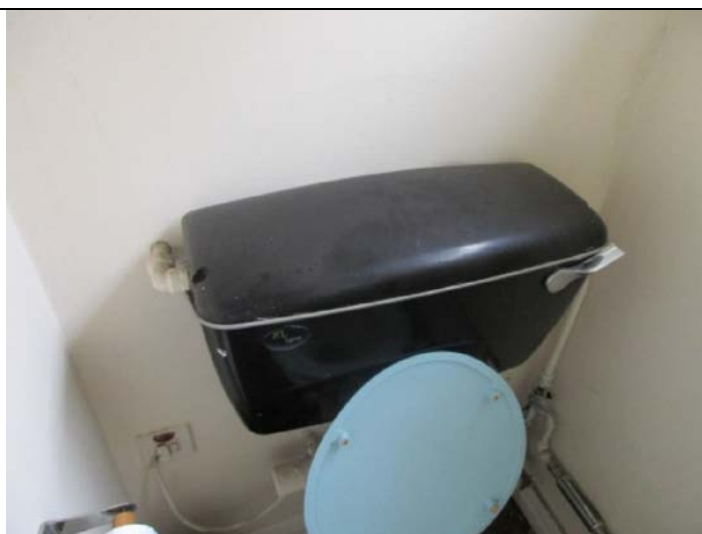
**Photograph No: 06**

<b>Product Type:</b>	REINFORCED PLASTIC	1	<b>Condition:</b>	LOW DAMAGE: A FEW SCRATCHES OR SURFACE MARKS	1
<b>Surface Treatment:</b>	COMPOSITE MATERIALS	0	<b>Location:</b>	ROOM <100 SQ MTR	0
<b>Asbestos Type:</b>	AMOSITE (BROWN)	2	<b>Amount:</b>	1 UNITS	
<b>Assessment Category</b>	VERY LOW		<b>MRA Score</b>		4

<b>Licensable:</b>	NO
<b>Comments:</b>	COMPOSITE TOILET CISTERN IN LADIES TOILET
<b>Recommendations:</b>	MANAGE AND LABEL

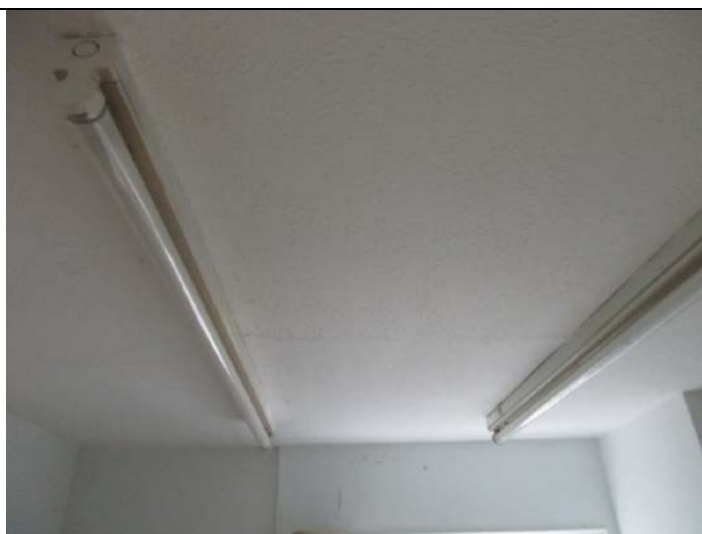
**Photograph No: 07**

<b>Licensable:</b>	N/A
<b>Comments:</b>	TEXTURED COATING TO KITCHEN CEILING
<b>Recommendations:</b>

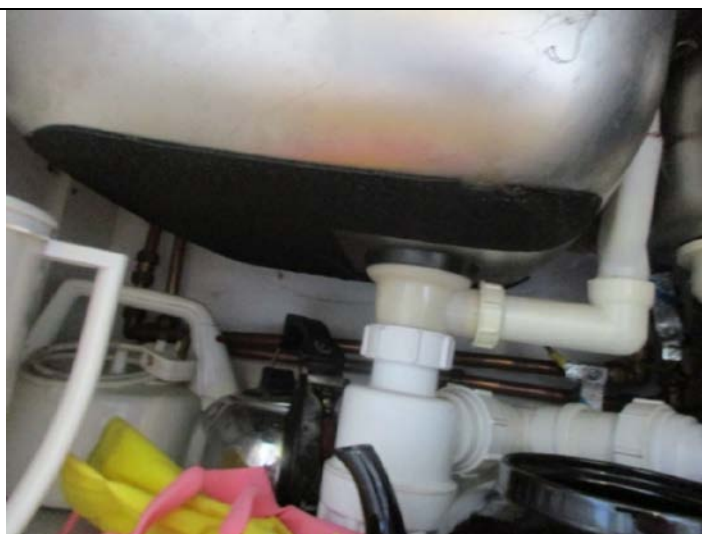
**Photograph No: 08**

<b>Product Type:</b>	BITUMEN	1	<b>Condition:</b>	LOW DAMAGE: A FEW SCRATCHES OR SURFACE MARKS	1
<b>Surface Treatment:</b>	COMPOSITE MATERIALS	0	<b>Location:</b>	ROOM <100 SQ MTR	0
<b>Asbestos Type:</b>	CHRYSTILE (WHITE)	1	<b>Amount:</b>	1 UNITS	
<b>Assessment Category</b>	VERY LOW		<b>MRA Score</b>		3

<b>Licensable:</b>	NO
<b>Comments:</b>	BITUMEN SINK PAD TO KITCHEN SINK
<b>Recommendations:</b>	MANAGE AND LABEL

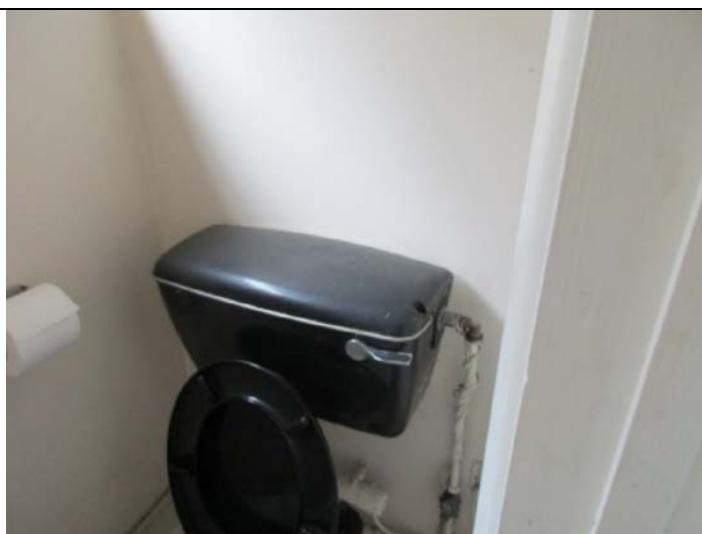
**Photograph No: 10**

<b>Product Type:</b>	REINFORCED PLASTIC	1	<b>Condition:</b>	LOW DAMAGE: A FEW SCRATCHES OR SURFACE MARKS	1
<b>Surface Treatment:</b>	COMPOSITE MATERIALS	0	<b>Location:</b>	ROOM <100 SQ MTR	0
<b>Asbestos Type:</b>	AMOSITE (BROWN)	2	<b>Amount:</b>	1 UNITS	
<b>Assessment Category</b>	VERY LOW		<b>MRA Score</b>		4

<b>Licensable:</b>	NO
<b>Comments:</b>	COMPOSITE TOILET CISTERN IN GENTS TOILET
<b>Recommendations:</b>	MANAGE AND LABEL

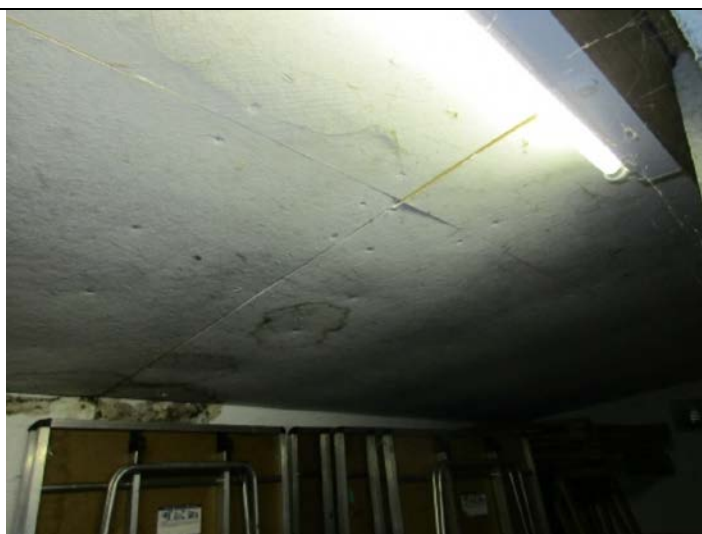
**Photograph No: 11**

<b>Licensable:</b>	N/A
<b>Comments:</b>	FIBREBOARD CEILING IN STORE ROOM
<b>Recommendations:</b>

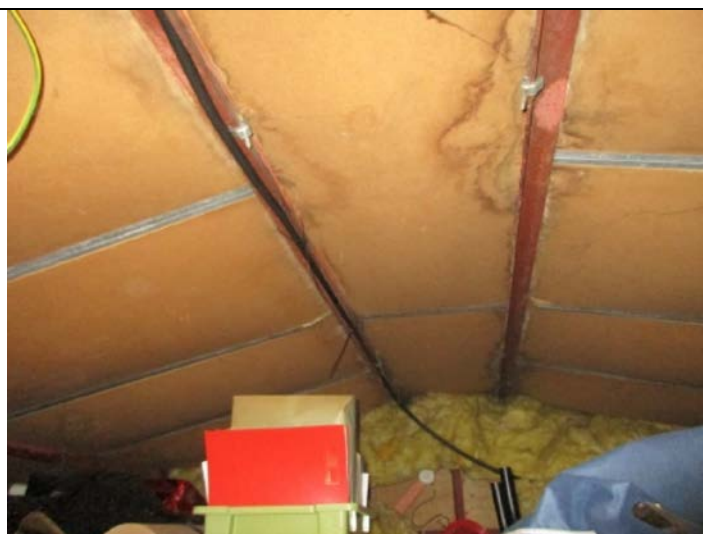
**Photograph No: 12**

<b>Licensable:</b>	N/A
<b>Comments:</b>	FIBREBOARD CEILING IN LOFT SPACE WITH EVIDENCE OF WATER DAMAGE
<b>Recommendations:</b>

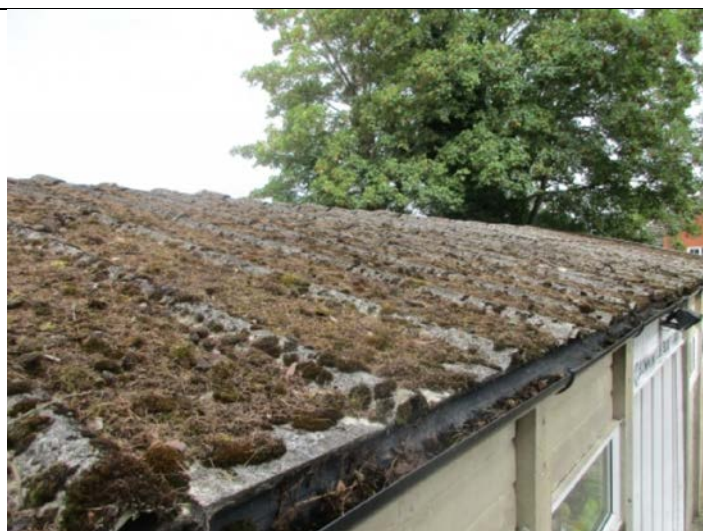
**Photograph No: 13**

Results Summary 1 (Asbestos Containing Materials)											
Building	Floor	Area	Description	Location Ref.	Asbestos Type	Amount	Material	Condition	Surface Treatment	Recommendations	Material Risk Score
SCOUT HQ	GROUND	EXTERNAL	CEMENT ROOF	WO16984/037	CHRYSTILE (WHITE)	100 SQ M	CEMENT PRODUCT	LOW DAMAGE: A FEW SCRATCHES OR SURFACE MARKS	COMPOSITE MATERIALS	MANAGE AND LABEL	4
SCOUT HQ	GROUND	GENT'S TOILET	COMPOSITE TOILET CISTERN	WO16984/027	AMOSITE (BROWN)	1 UNITS	REINFORCED PLASTIC	LOW DAMAGE: A FEW SCRATCHES OR SURFACE MARKS	COMPOSITE MATERIALS	MANAGE AND LABEL	4
SCOUT HQ	GROUND	KITCHEN	BITUMEN SINK PAD	WO16984/022	CHRYSTILE (WHITE)	1 UNITS	BITUMEN	LOW DAMAGE: A FEW SCRATCHES OR SURFACE MARKS	COMPOSITE MATERIALS	MANAGE AND LABEL	3
SCOUT HQ	GROUND	LADIES TOILET	COMPOSITE TOILET CISTERN	WO16984/016	AMOSITE (BROWN)	1 UNITS	REINFORCED PLASTIC	LOW DAMAGE: A FEW SCRATCHES OR SURFACE MARKS	COMPOSITE MATERIALS	MANAGE AND LABEL	4

<b>Product Type:</b>	CEMENT PRODUCT	1	<b>Condition:</b>	LOW DAMAGE A FEW SCRATCHED OR SURFACE MARKS	1
<b>Surface Treatment:</b>	CEMENT PRODUCT	1	<b>Location:</b>	ROOM <100 SQ MTR	0
<b>Asbestos Type:</b>	CHRYBOTILE (WHITE)	1	<b>Amount:</b>	100 SQ M	
<b>Assessment Category</b>	VERY LOW		<b>MRA Score</b>		4

<b>Licensable:</b>	NO
<b>Comments:</b>	CEMENT SHEET ROOFING, GENERAL GOOD CONDITION WITH LOW DAMAGE
<b>Recommendations:</b>	MANAGE AND LABEL
